cornwall
environmental
consultants LTD

**Falmouth Harbour, Church Street
site – Baseline Monitoring
Report**

22 March 2023

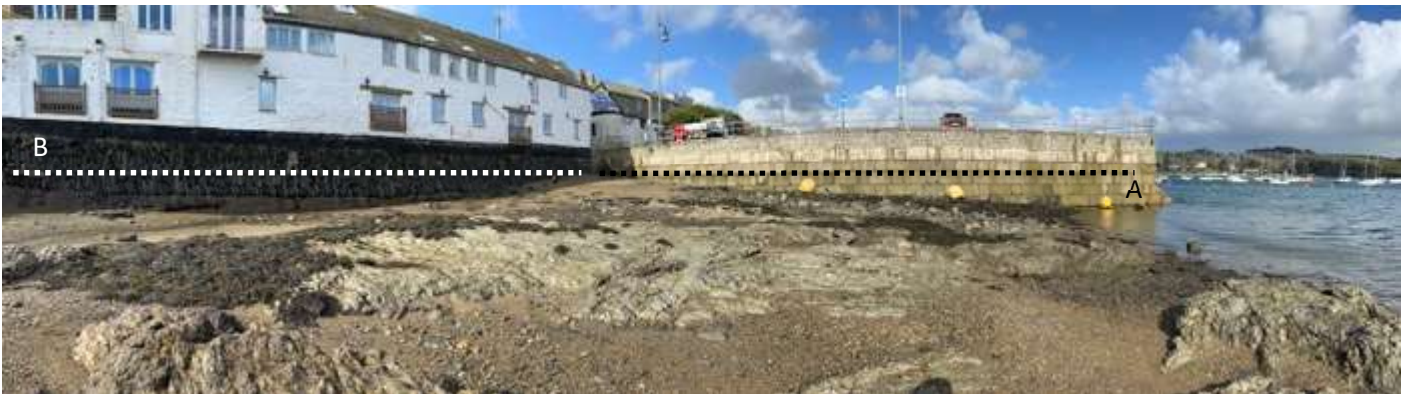
Figure 2: Site Overview – Seawall A (black dotted line), Seawall B (white dotted line)

3.1.1. The site (Figure 2) is comprised of an area of littoral rock and sediment in front of two perpendicular sea walls. Seawall A is constructed from stone/cobbles while Seawall B is constructed from concrete blocks. The littoral sediment is comprised of sand, shingle, and mixed substrate, some influenced by freshwater.
